OTTAWA ROAD 174 AT JEANNE D'ARC
PIPE COLLAPSE

ROOT CAUSE ANALYSIS REPORT

December 7, 2012

B. M. ROSS AND ASSOCIATES LIMITED
Engineers and Planners
62 North Street
Goderich, ON N7A 2T4
Phone: 519-524-2641
Fax: 519-524-4403
www.bmross.net

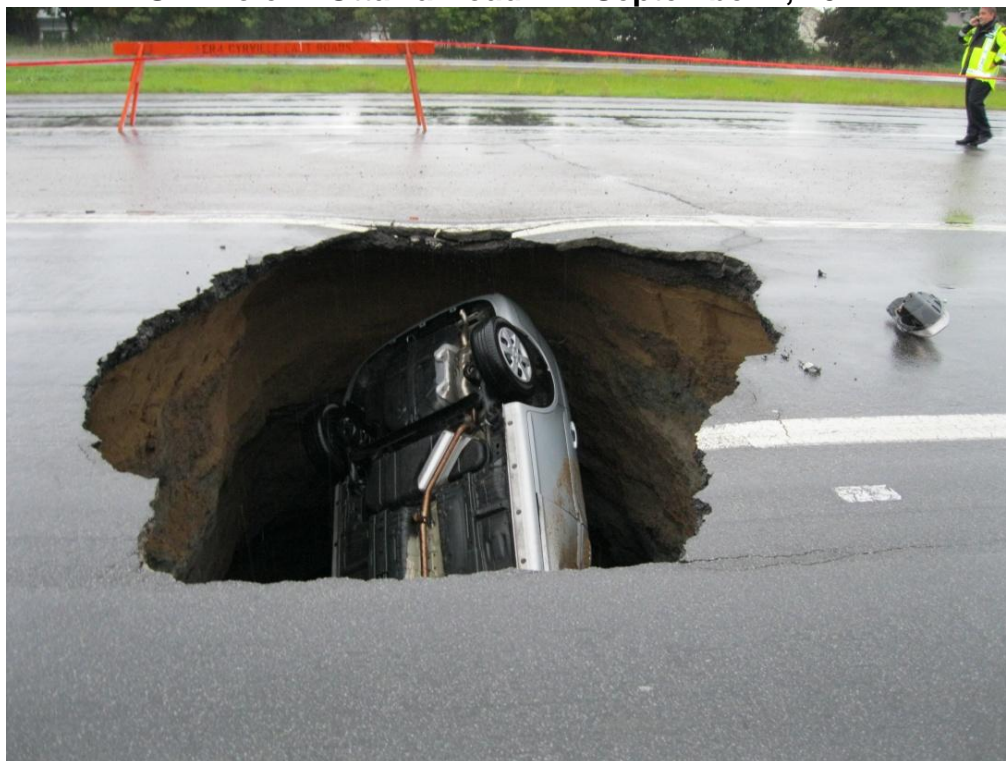
Figure 2.1
Sinkhole in Ottawa Road 174 September 4, 2012

flow in the storm sewer system. Shortly thereafter, at approximately 5:00 p.m., a substantial sinkhole developed within the exit ramp driving lane approximately 41 metres (m) north of the pipe headwall. Figure 2.1 shows a photograph of the sinkhole taken on September 4, 2012, hours after a car had been lodged in it.

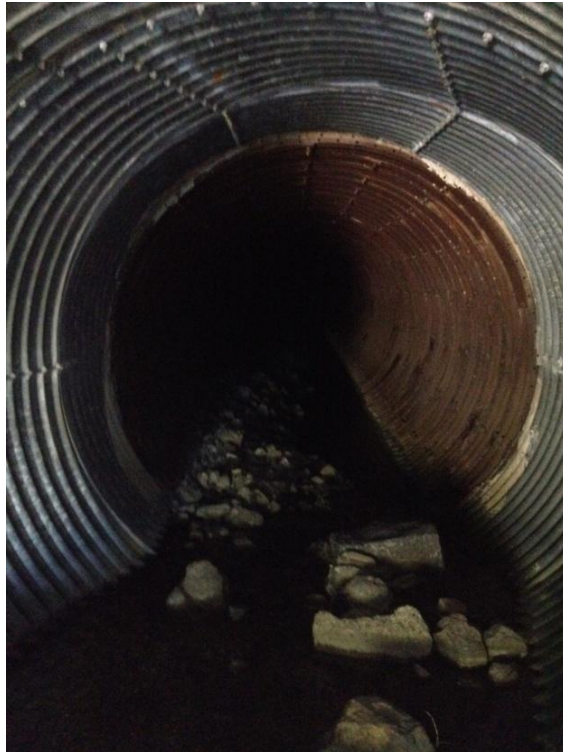
Figure 3.2
Transition from CSP to Liner Plate – July 2012

Figure 3.2 is a photograph taken in July 2012, showing the transition from CSP to liner plate. The photo was taken during the tendering period for the re-lining project by a representative of a pipe supplier for the proposed liner whose interest was the nature of the bend in the pipe.
