**OTTAWA ROAD 174 AT JEANNE D'ARC
PIPE COLLAPSE**

ROOT CAUSE ANALYSIS REPORT

December 7, 2012

B. M. ROSS AND ASSOCIATES LIMITED
Engineers and Planners
62 North Street
Goderich, ON N7A 2T4
Phone: 519-524-2641
Fax: 519-524-4403
www.bmross.net

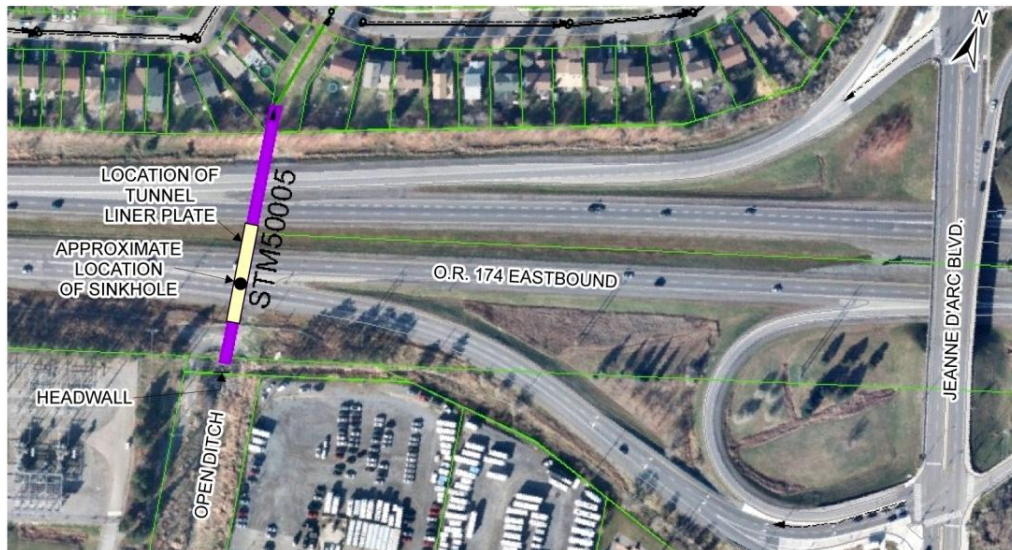
Figure 3.1
Location of STM50005

STM 50005, as shown in figure 3.1, could be considered to be somewhat unique in that it was partially constructed of un-galvanized tunnel liner plate in a corrosive environment with conventional galvanized CSP on both ends.

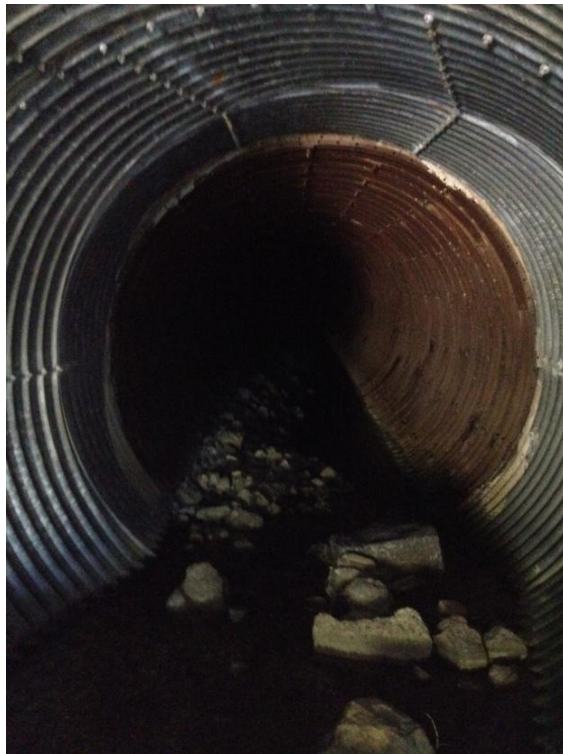
Figure 3.2
Transition from CSP to Liner Plate – July 2012

Figure 3.2 is a photograph taken in July 2012, showing the transition from CSP to liner plate. The photo was taken during the tendering period for the re-lining project by a representative of a pipe supplier for the proposed liner whose interest was the nature of the bend in the pipe.
