**OTTAWA ROAD 174 AT JEANNE D'ARC  
PIPE COLLAPSE**

**ROOT CAUSE ANALYSIS REPORT**

December 7, 2012

B. M. ROSS AND ASSOCIATES LIMITED  
Engineers and Planners  
62 North Street  
Goderich, ON N7A 2T4  
Phone: 519-524-2641  
Fax: 519-524-4403  
[www.bmross.net](http://www.bmross.net)

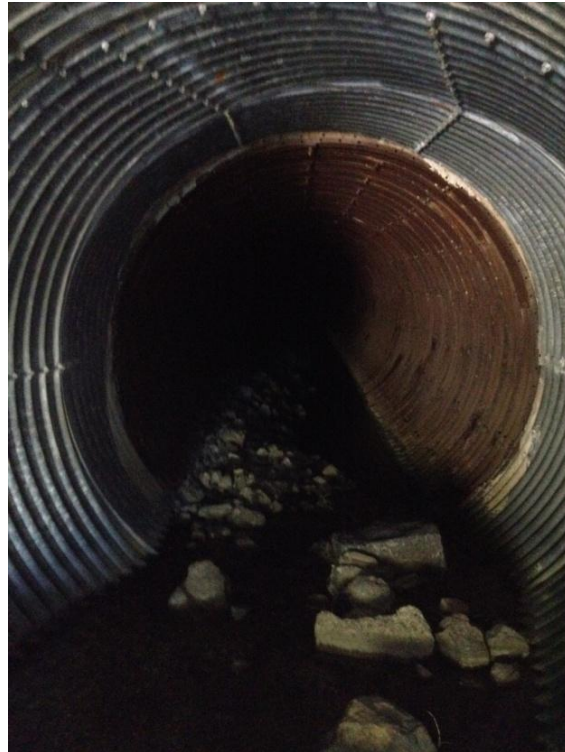
**Figure 3.2**  
**Transition from CSP to Liner Plate – July 2012**

STM 50005, as shown in figure 3.1, could be considered to be somewhat unique in that it was partially constructed of un-galvanized tunnel liner plate in a corrosive environment with conventional galvanized CSP on both ends.

Figure 3.2 is a photograph taken in July 2012, showing the transition from CSP to liner plate. The photo was taken during the tendering period for the re-lining project by a representative of a pipe supplier for the proposed liner whose interest was the nature of the bend in the pipe.

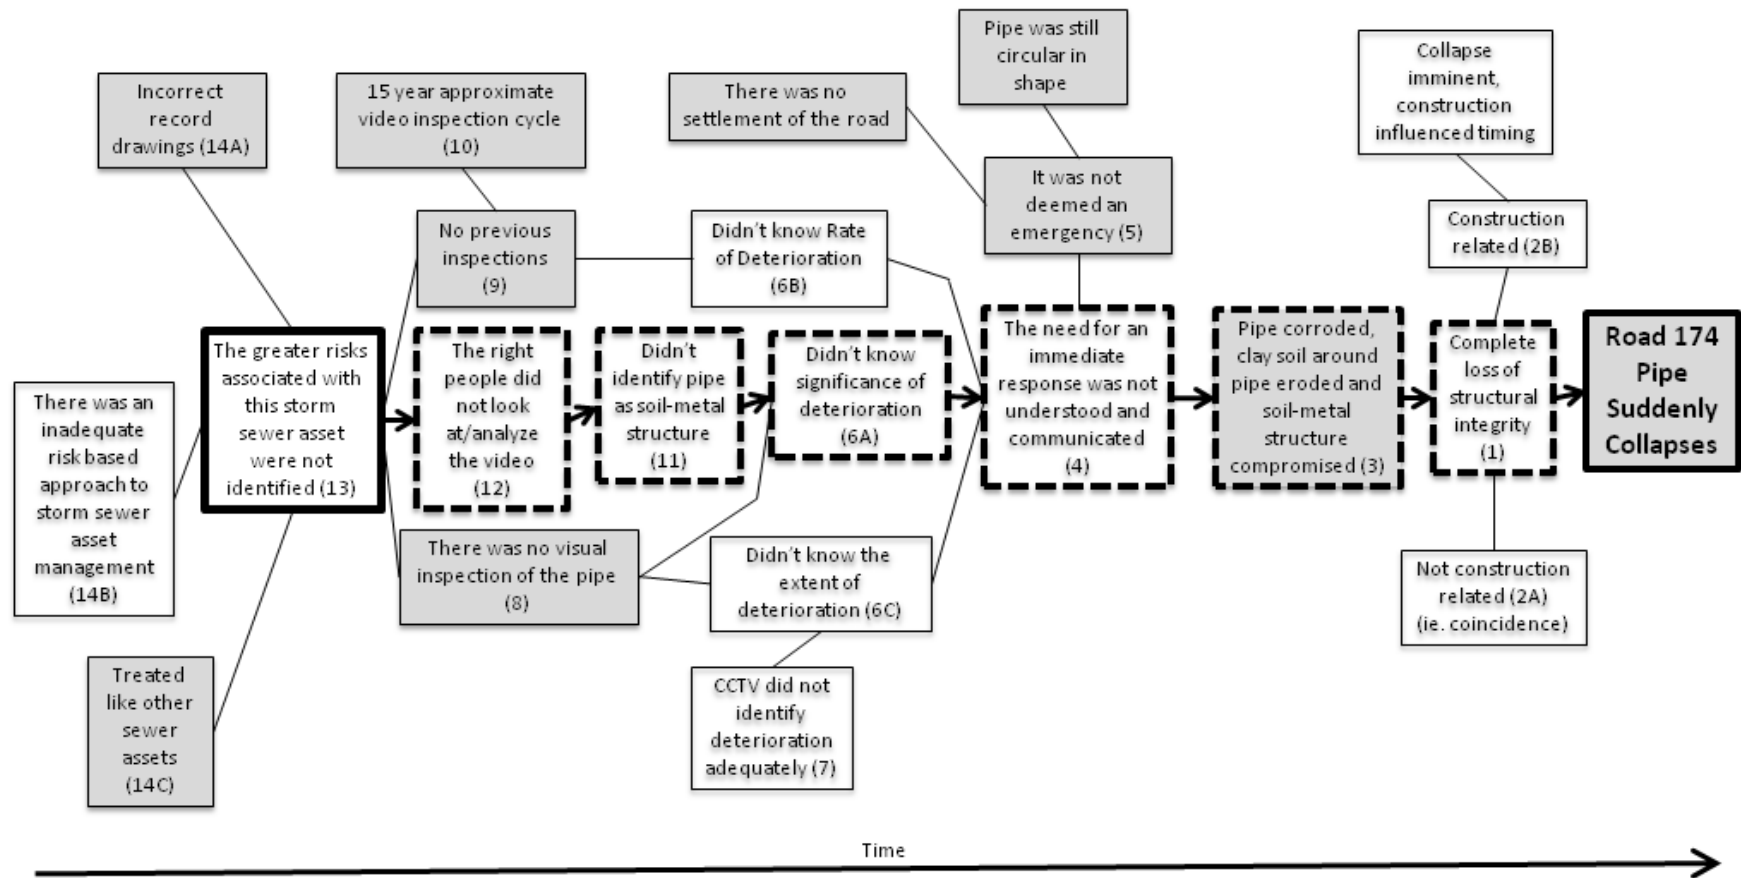
Figure 5.1  
Root Cause Analysis  
Diagram

Figure 5.1 provides a visual summary of the findings of the RCA. The event (the collapse of the pipe) is presented on the extreme right and causes for the event are presented right to left, moving backwards towards the root cause(s). Facts established through the investigation are presented in a shaded box. Where a cause is our “opinion”, based on the investigation, it is presented in an unshaded box.

In conclusion, it is our opinion that the root cause of failure of the pipe beneath Ottawa Road 174 was that the structure's inherently greater risks were not identified and acted on before the pipe's structural integrity was lost.
