**CITY OF OTTAWA**

**OTTAWA ROAD 174 AT JEANNE D'ARC**  
**PIPE COLLAPSE**

**ROOT CAUSE ANALYSIS REPORT**

December 7, 2012

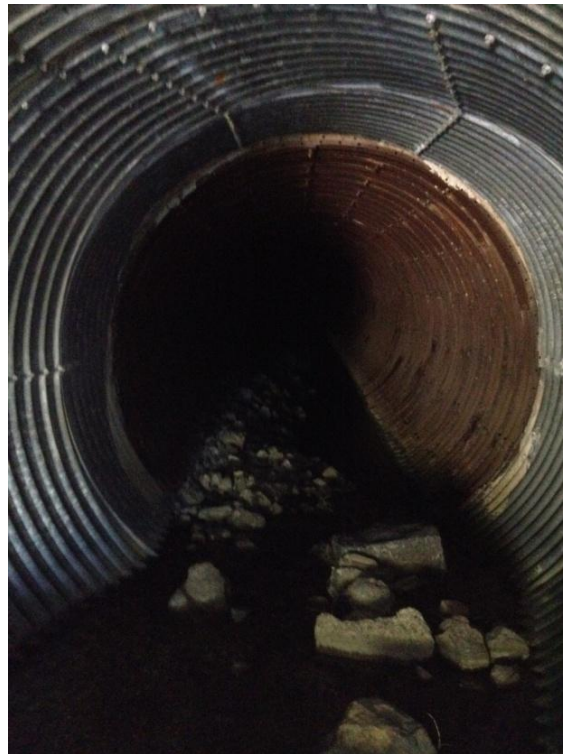
**Figure 3.2**  
**Transition from CSP to Liner Plate – July 2012**

Figure 3.2 is a photograph taken in July 2012, showing the transition from CSP to liner plate. The photo was taken during the tendering period for the re-lining project by a representative of a pipe supplier for the proposed liner whose interest was the nature of the bend in the pipe.

The CCTV inspection<sup>4</sup> on August 17, 2011 identified that the CSP sections upstream and downstream of the liner plate section were in reasonably good condition, but the 48 m liner plate section was severely corroded. At approximately 36.5 m to 38 m from the pipe entrance, two holes were observed. One at the 5 o'clock position, which was approximately 1.1 m<sup>2</sup> in area, and the other at the 8 o'clock position, which was approximately 0.9 m<sup>2</sup>. Significant corrosion was evident throughout the liner plate section of pipe.
