OTTAWA ROAD 174 AT JEANNE D'ARC
PIPE COLLAPSE

ROOT CAUSE ANALYSIS REPORT

December 7, 2012

B. M. ROSS AND ASSOCIATES LIMITED
Engineers and Planners
62 North Street
Goderich, ON N7A 2T4
Phone: 519-524-2641
Fax: 519-524-4403
www.bmross.net

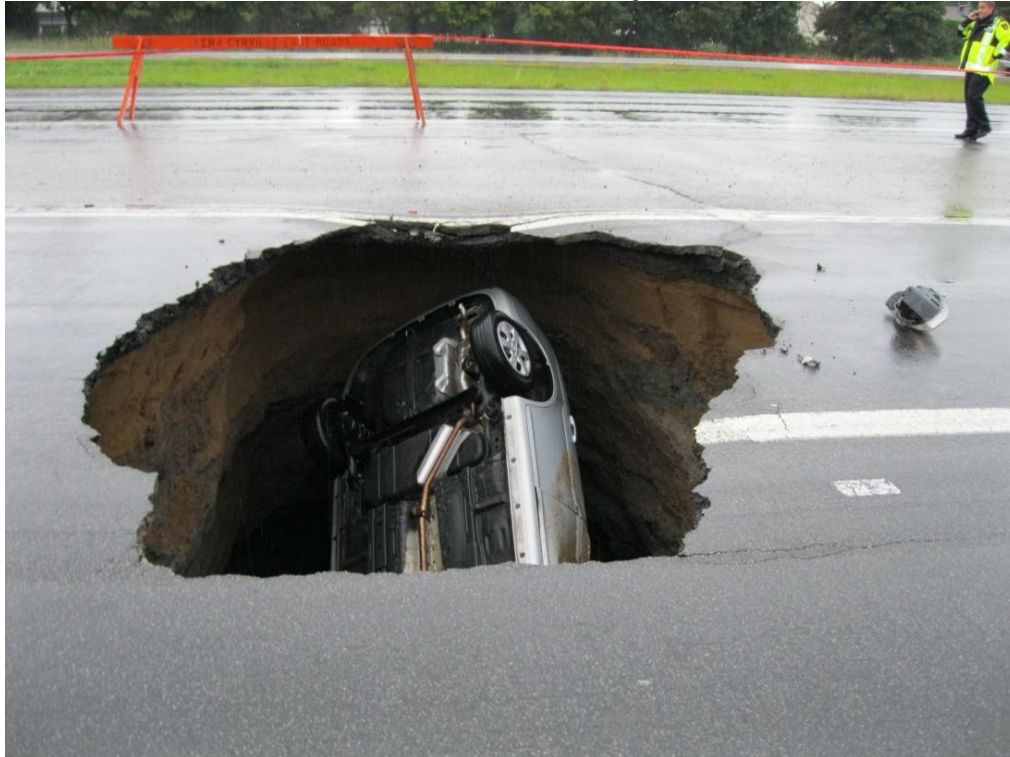
Figure 2.1
Sinkhole in Ottawa Road 174 September 4, 2012

flow in the storm sewer system. Shortly thereafter, at approximately 5:00 p.m., a substantial sinkhole developed within the exit ramp driving lane approximately 41 metres (m) north of the pipe headwall. Figure 2.1 shows a photograph of the sinkhole taken on September 4, 2012, hours after a car had been lodged in it.
