July 31, 2018
Project No. 18184

**Re: 1119 Wellington Street West
Partial Demolition Review and Investigation**

PARTIAL DEMOLITION

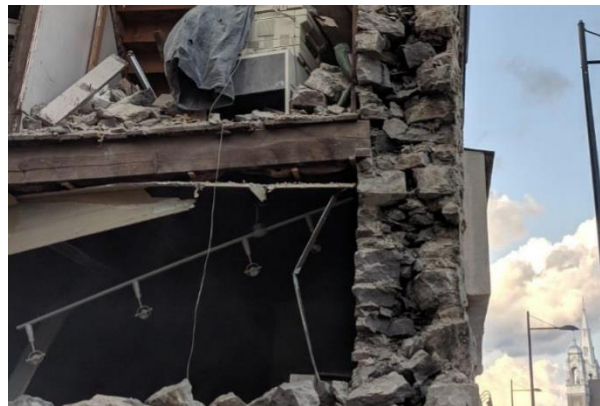
Figure 1: Bearing of 2nd Floor Joist

The floor joists at the second floor were found to be connected to a wood ledger embedded in the wall and was critical to the support of the wall above. It was decided that the failed joist would remain since its removal would cause further instability of the wall above.

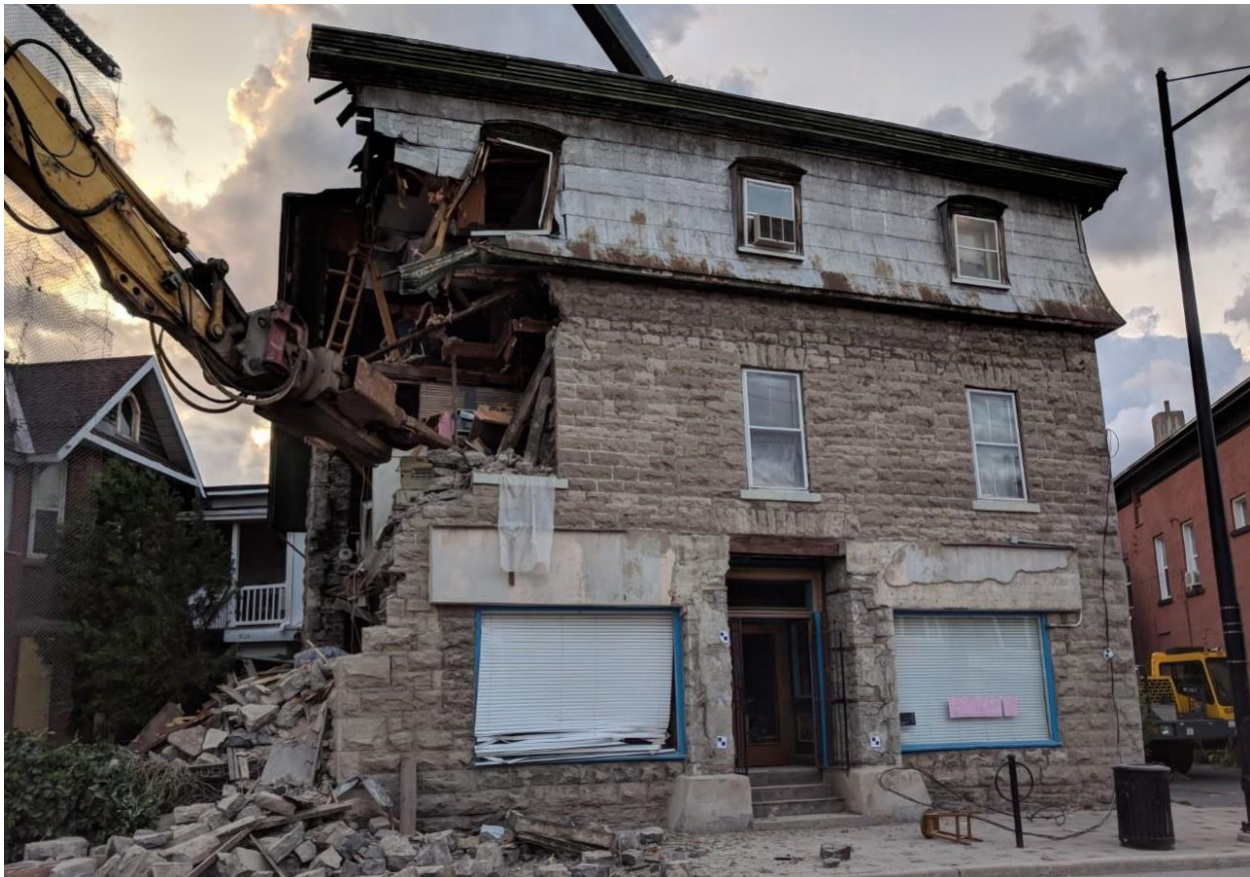
Demolition began by removal of metal siding to further expose the unstable upper area at the south of the West Elevation. Once siding was removed, the cross section was accessible and a large area of masonry was dislodged and collapsed to the existing rubble pile in a controlled manner. Following this dismantle, the condition of the roof appeared stable and PDI returned to the corner to address all unstable masonry for the remainder of the corner. With the west return of the masonry removed, PDI continued at the roof and mansard to gain access to unstable masonry at the upper west corner of the South Elevation. The masonry at the second floor west of the window was removed, as was the window. The conditions presented following the removal of the window offered relative stability and it was decided that this would be the extent of masonry demolition.

Figure 2: Extent of Partial Demolition (approx.)

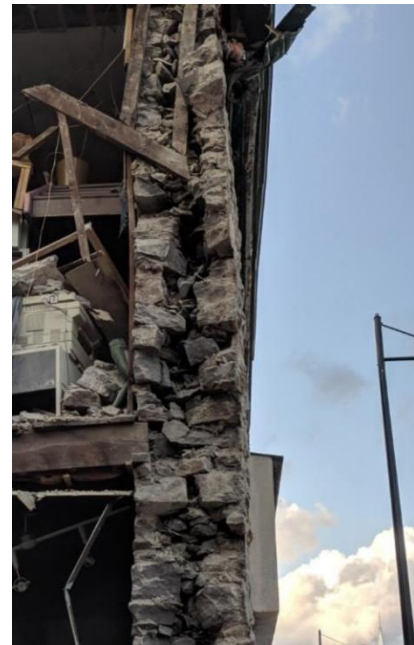
With our previous report we noted several indications to suggest the remainder of the masonry structure could be in comparable condition to the West Elevation. This was confirmed at the South Elevation during the partial demolition activities. The demolition at the corner offered a cross-section view of the masonry revealing that the condition of the masonry core is very poor. The previously observed bulge in the wall just above the concrete lintels can be attributed to buckling of the outer wythe of stone; there is no connection to the core or the interior wythe (fig.3).

Figure 3: South Elevation - Empty Wall Core

Based on our detailed review of July 25th and 27th and observations during the partial demolition, we continue to support the recommendations outlined in our report dated July 26th. It is our opinion that the remaining walls have deteriorated to the extent that they cannot be restored in place safely as removal of one stone may immediately create instability in the wall leading to a collapse. We recommend full dismantle of the original building.
