# Field Review Report

**PROJECT** 227 Mackay **PROJECT No** 5624-35

**CLIENT** Derek Crain Architect Inc **REPORT No** AAR-01

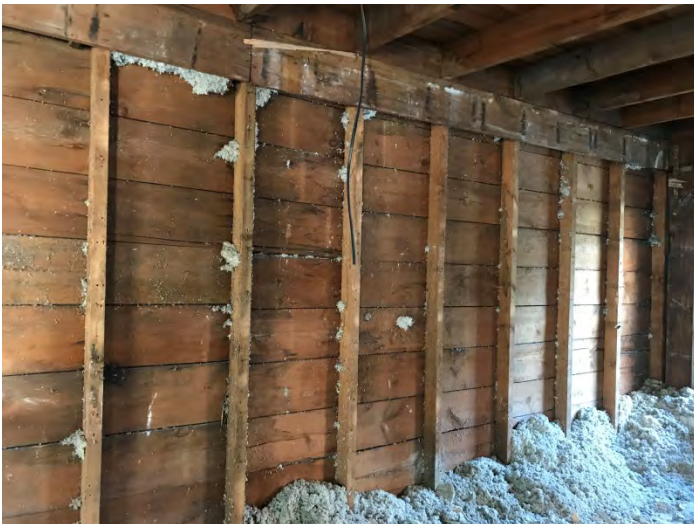
Existing Picture 1 – Existing East Wall

4. The Existing Walls are Balloon Frame (Two Storey, Continuous Stud) Construction.
5. The wall studs vary are between 25"-27" on centre.
6. The bearing capacities for these walls, as constructed, do not meet current OBC requirements.
7. Some of the wall studs on the North and East walls, which were intended to be reused, may be too dry and too cracked for safe reuse.
8. Roof, Floor and Wall structures of this building are incompatible with current OBC requirements.
9. The efficiency of reuse of these elements is a question.

1. The existing Balloon frame of the old structure must be adapted to a western frame wood structure if there is any chance of reuse.
2. The North and East wall (part) studs should be labelled and cataloged for reuse.
3. If studs are to be reused, they must be re-inspected by this firm prior to use.
4. The studs, once approved for reuse, could they could be integrated into a western style 2x6 frame system with studs at 16" c/c.

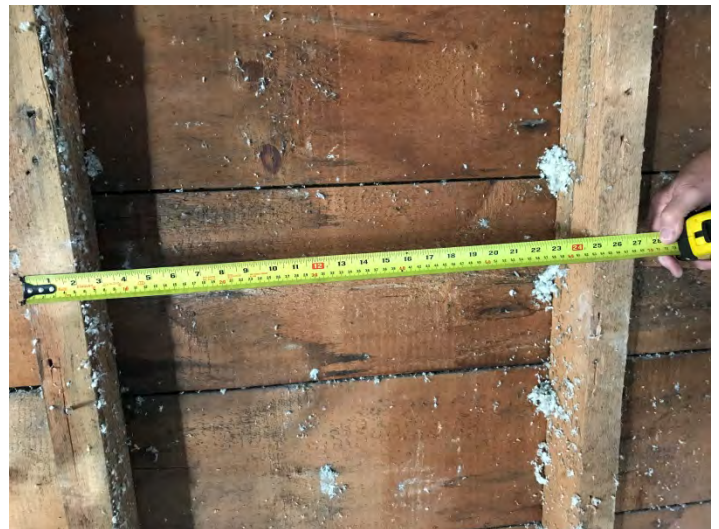
Studs Picture 2 – Spacing of existing East Wall

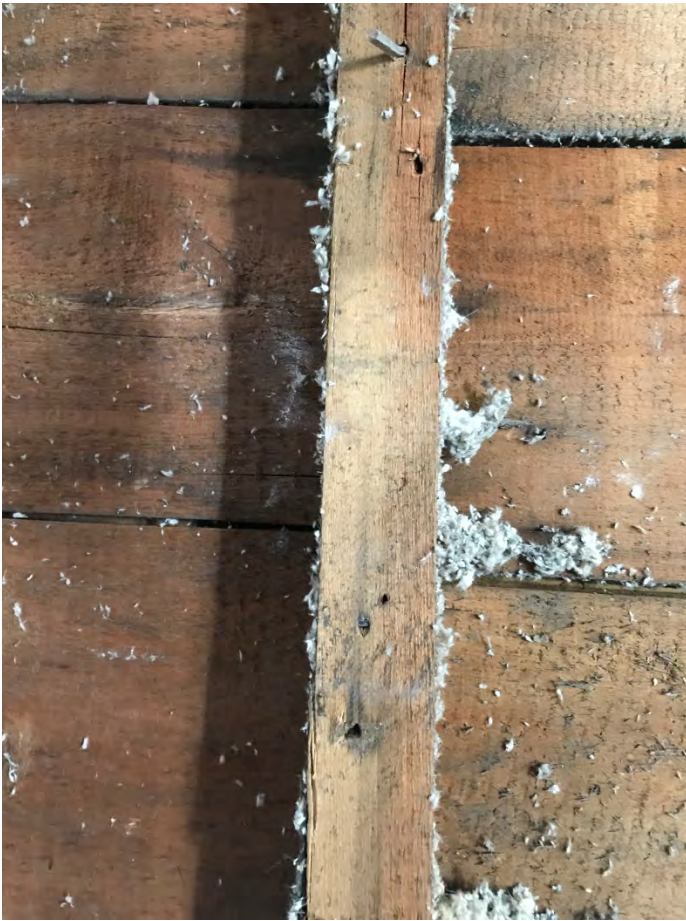
Picture 3 – East Wall Stud

It should be noted that some of the existing 2" x 4" studs have some splitting and deterioration, as noted in pictures 3 & 4. There is some concern that in the salvaging of these existing studs, the removal of the exterior wall system and /or local nails may cause more deterioration and/or splitting. A review of salvaged 2" x 4" studs will need to be done to verify damage and effects on the structural integrity of each member before it can be used as part of the proposed framing of the exterior wall. As well, a new 2" x 6" member will be required at each salvaged stud location to maintain the required architectural envelope.

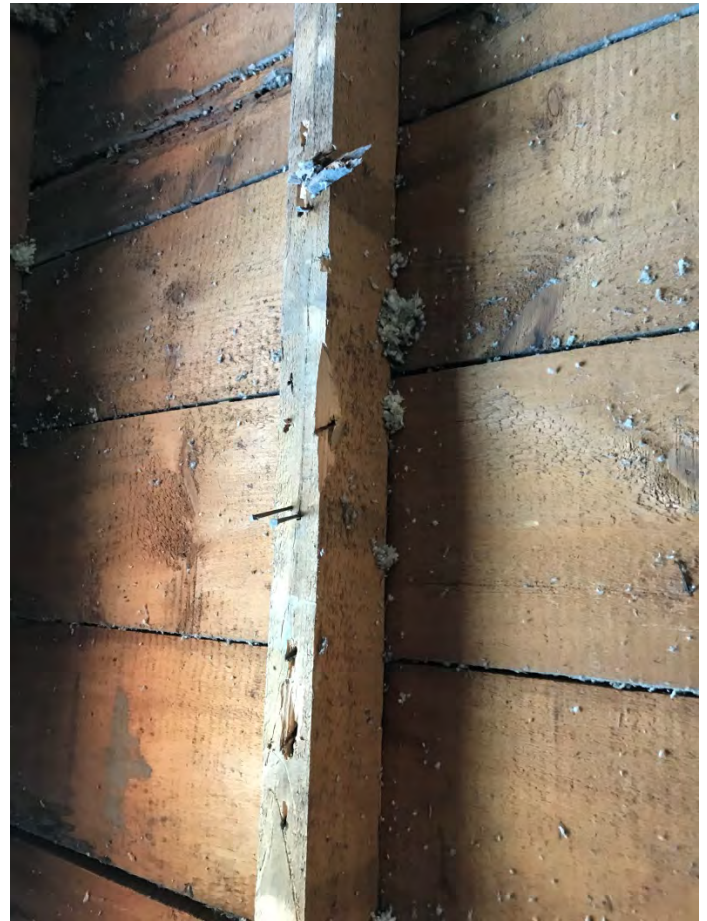
Picture 4 – East Wall Stud
