# Corrective Action Plan - TCMS

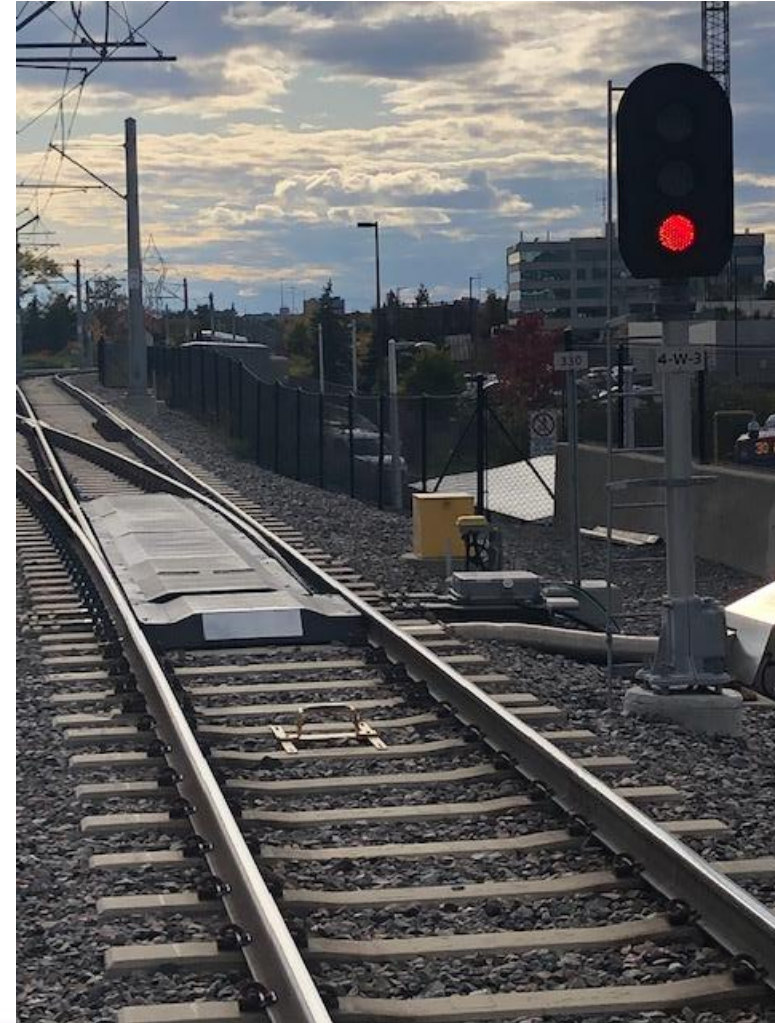
- RTG and RTM have been directed to have dedicated guideway technicians assigned at terminus stations during peak periods;
- A complete inspection and review of all switches has also been ordered;
- Switch covers, which were installed to assist with the upcoming winter season, have been removed at Tunney's and Blair Stations, and will be removed at other locations; and,
- Switch maintenance, inspection plans and greasing programs will be revisited to ensure reliability.

- Staff directed RTM to remove winter switch covers, which were contributing to switch problems;
- Additional resources have been brought in by RTM to address potential issues with the switches; and,
- Enhanced monitoring has been implemented to ensure active elements such as switch heaters are functioning properly.
