February 27, 2013 Winter Storm Event Transit Services Department

**Transit Commission
March 25, 2013**

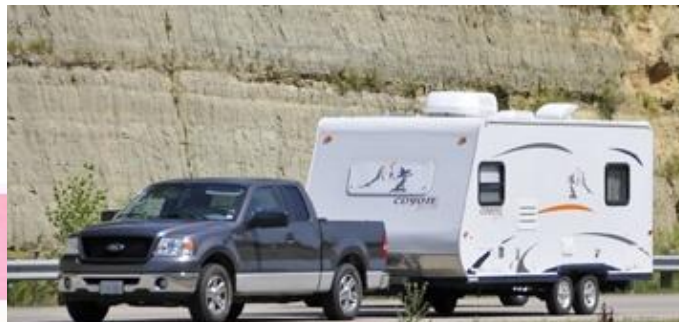
Articulated Bus Operation

Articulated Bus- Rear Engine, Pusher Trailer section pushing the Bus

It's like having your camper push your car

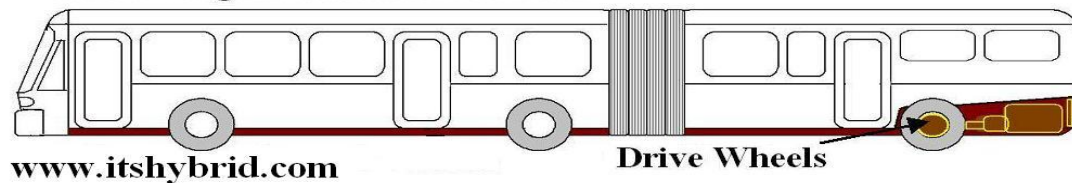
Before

Rear Engine Articulated Bus.

Hydraulic Traction Drive

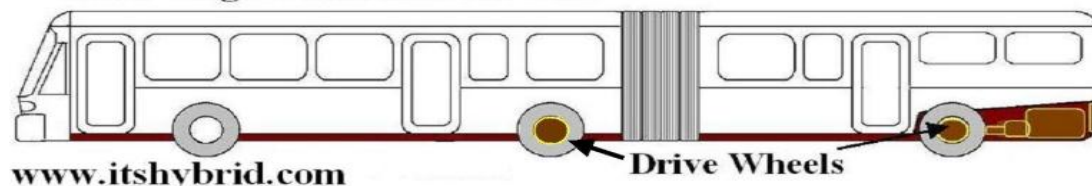
After conversion

Rear Engine Articulated Bus. 6X4
