## HERITAGE SURVEY AND EVALUATION FORM

Municipal Address	518 Mariposa Crescent	Building or Property Name	042260005				
Legal Description	PLAN 536 PT LOTS 5 AND 6	Lot	PT 5, 6	Block		Plan	536
Date of Original Lot Development		Date of current structure	1954				
Additions		Original owner	Arnold C. Smith, C. H. and Evelyn Hardwick Stewart Smith

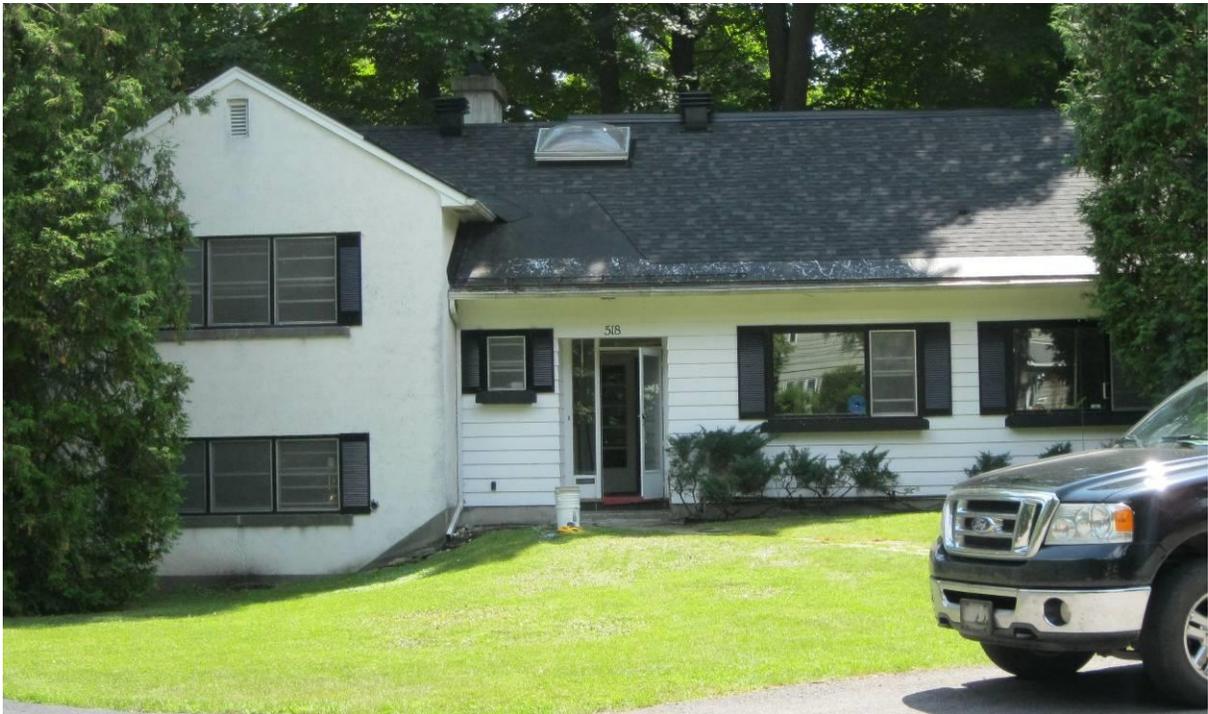
Main Building

<b>Architecture</b>	Prepared by: Heather Perrault / Brittney Bos
	Month/Year: July 2010
Architectural Design (plan, storeys, roof, windows, style, material, details, etc)	
<p>This 1 ½ storey building is rectangular in plan and is capped by a medium pitched cross gabled roof. The eastern section is stucco while the western section is clad in siding. On the eastern section, the basement opens to a full half storey. Both storeys contain matching multi paned rectangular windows divided vertically in three with shutters. The western section is one storey in height and contains the front entrance on the east side flanked by a side light and a small rectangular window with shutters. On the other side of the entrance are two horizontal windows with shutters. It is unclear what is behind the large cedar planting in front, however there is an attached carport on the west facade. There is an interior stucco chimney on the south roof slope.</p>

Architectural Style	
<p>Split level: Characterized by a variety of floor heights and less clear storey lines. This style of architecture also promoted an integration of garages within the overall design of the building. This architectural trend was reflective of the cultural shift in which the automobile became a central component within suburban development.</p>	
Designer / Builder / Architect	
<p>Built by James Patterson and Son. Ottawa contracting firm active in the late 1950s</p>	
Architectural Integrity	
<p>Decorative shutters have been added to the window. A skylight has been installed.</p>
