1. **Application to Demolish Magee House, 1119 Wellington Street West, a Property Designated Under Part IV of the *Ontario Heritage Act***

File Number: ACS2018-PIE-RHU-0022

SUBJECT: Application to Demolish Magee House, 1119 Wellington Street West, a Property Designated Under Part IV of the *Ontario Heritage Act*

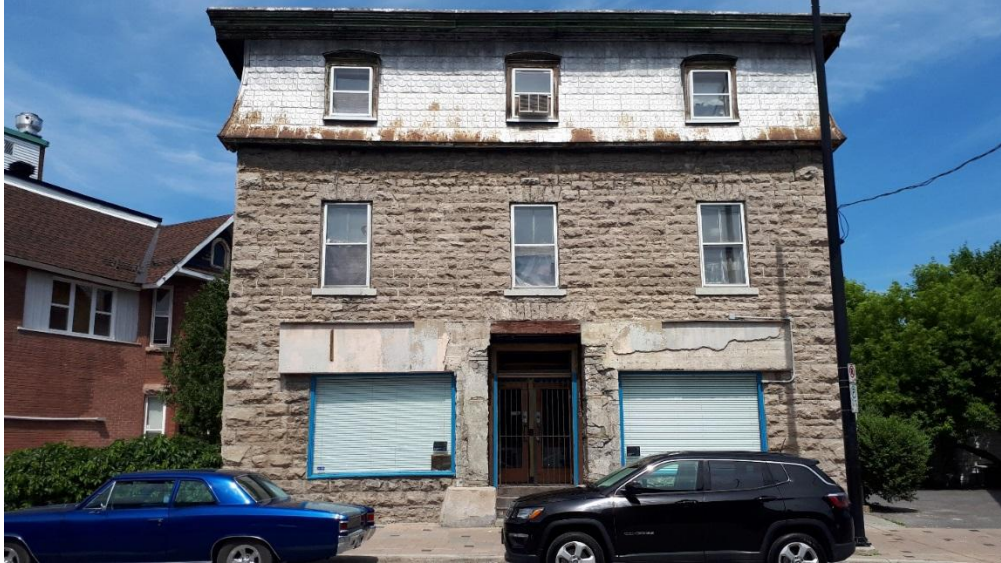
1119 Wellington Street West prior to collapse

The 2 ½ storey building is one of the few remaining stone structures in the area. The Second Empire detailing, in particular, the mansard roof with its dormers and emphatic cornice, is unique in the neighbourhood and serves to add the landmark status of the structure.

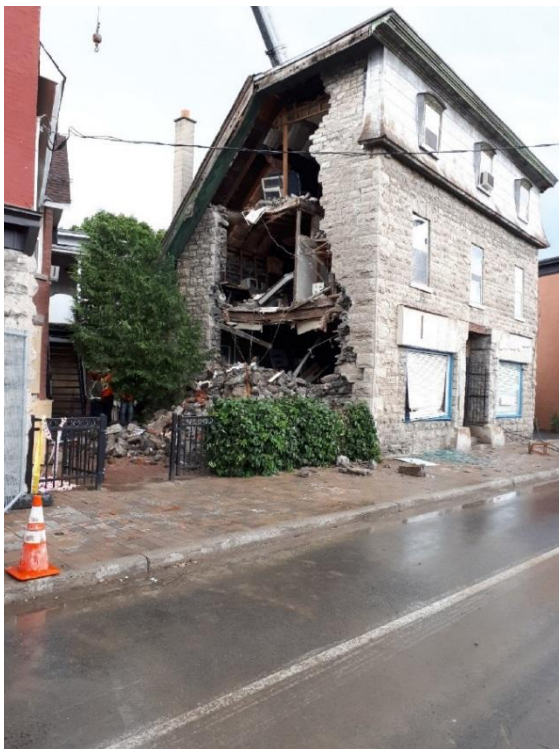
1119 Wellington Street West following collapse

The west wall of the building partially collapsed on July 24, 2018. On July 25, 2018, the City of Ottawa commissioned John G. Cooke and Associates Ltd. to review the condition of the structure following the collapse. The complete report is attached as Document 4. The findings of the initial review stated that,

“The condition of the core of the wall adjacent to the collapsed areas is in very poor condition, the mortar’s binder has been washed away after several years of water infiltration. There is little to no indication of any mortar remaining in the core of the wall.”

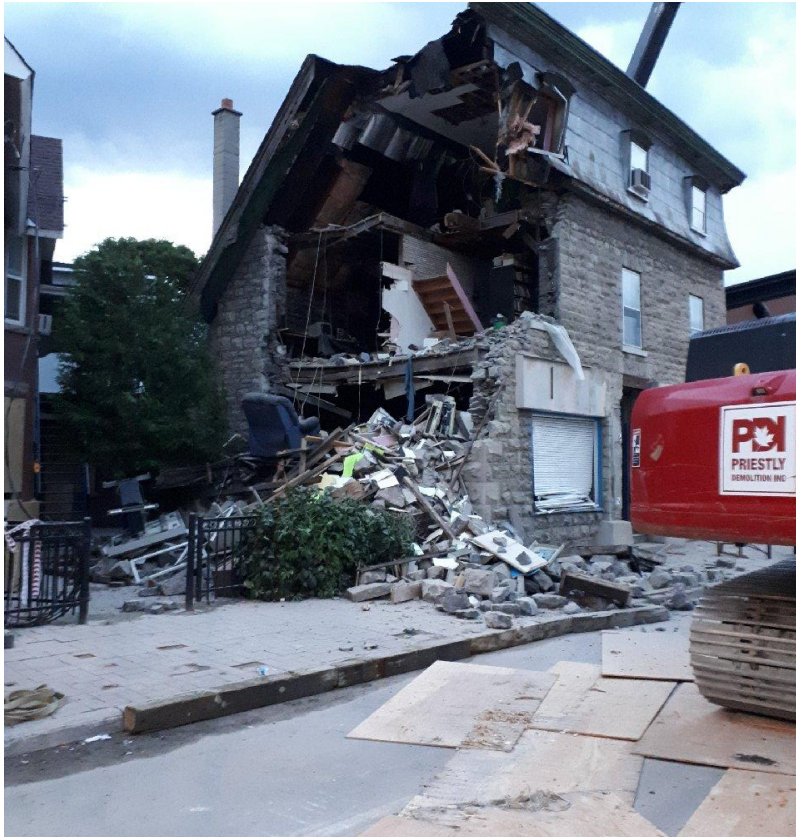
1119 Wellington Street West following partial demolition

1. Removal of the upper area of the southern end of the west facing wall
2. Removal of the western section of the flat and sloped roof
3. Removal of the remaining masonry at the southwest corner

Following the demolition work carried out on July 27, 2018, John G. Cooke and Associates Ltd. provided an update to their July 26 report, dated July 31 and attached as Document 5. This report outlined the demolition work that was undertaken as well as the condition of the remaining structure and the recommended future actions. The report includes the following assessment of the structure:

“The demolition at the corner offered a cross-section view of the masonry revealing that the condition of the masonry core is very poor. The previously observed bulge in the wall just above the concrete lintels can be attributed to buckling of the outer wythe of stone; there is no connection to the core or the interior wythe.

During the demolition, the condition of the roof deck was noted to be severely deteriorated. This was observed during removals using the hydraulic shear; the wood roof decking offered little resistance when removed.”
